# Sewer CCTV Inspection Report

**Date:** 5/27/2023  
**Pipe Length:** 119.59 m  
**Pipe Diameter:** 800 mm  
**Material:** Cement  
**Pipe Segment:** JS.5~MH-38  
**Location:** JS.5  
**Start MH:** MH-38  
**End MH:** JS.5  
**Direction of Survey:** Downstream

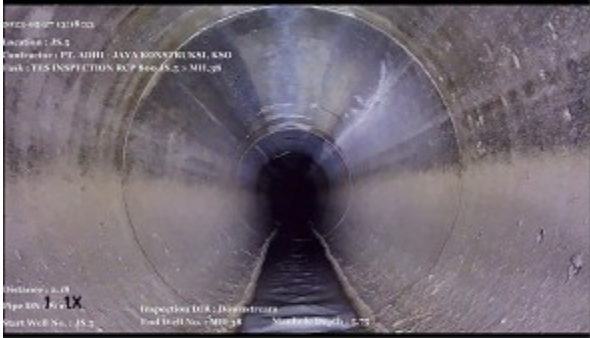
| Distance | Fault Observation | Time | Picture |
|---|---|---|---|
| 2.18 m | Remark: SAMBUNGAN KE 3 (OK) | 160 s | |

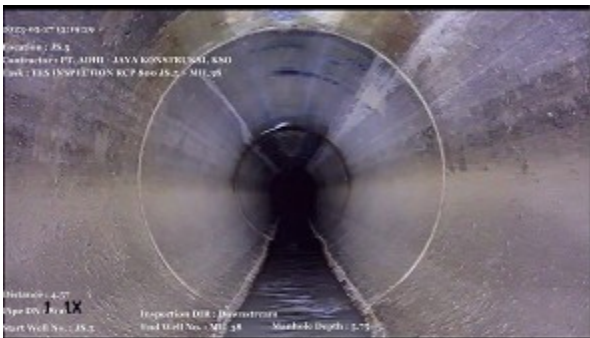
| Distance | Fault Observation | Time | Picture |
|---|---|---|---|
| 4.57 m | Remark: SAMBUNGAN KE 4 (OK) | 217 s | |

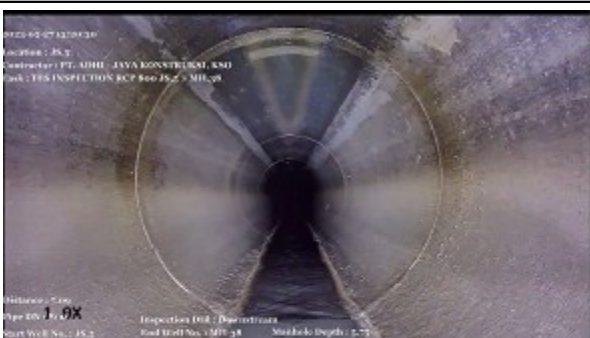
| Distance | Fault Observation | Time | Picture |
|---|---|---|---|
| 7.09 m | Remark: SAMBUNGAN KE 5 (OK) | 278 s | |

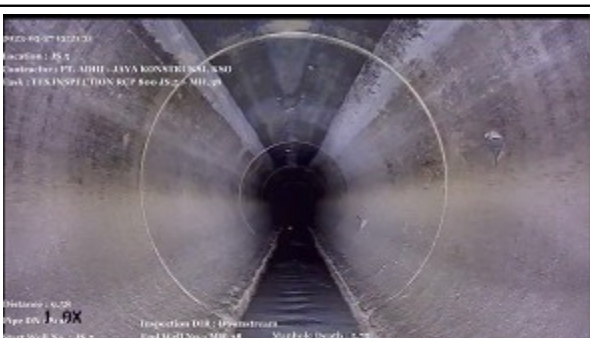
| Distance | Fault Observation | Time | Picture |
|---|---|---|---|
| 9.58 m | Remark: SAMBUNGAN KE 6 (OK) | 339 s | |

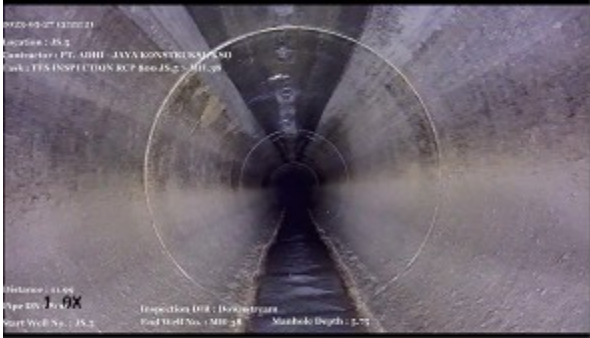
| Distance | Fault Observation | Time | Picture |
|---|---|---|---|
| 11.99 m | Remark: SAMBUNGAN KE 7 (OK) | 389 s | |

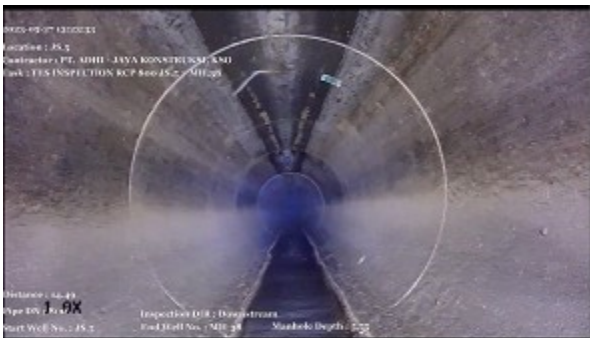
| Distance | Fault Observation | Time | Picture |
|---|---|---|---|
| 14.49 m | Remark: SAMBUNGAN KE 8 (OK) | 460 s | |

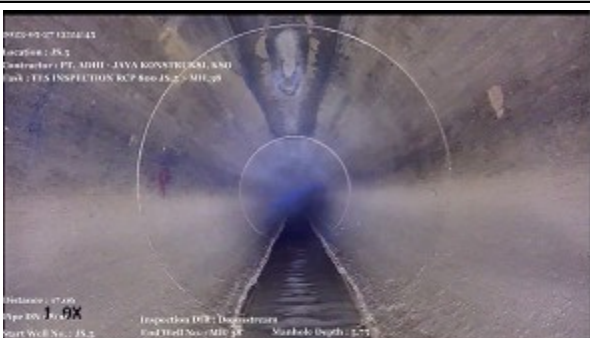
| Distance | Fault Observation | Time | Picture |
|---|---|---|---|
| 17.06 m | Remark: SAMBUNGAN KE 9 (OK) | 532 s | |

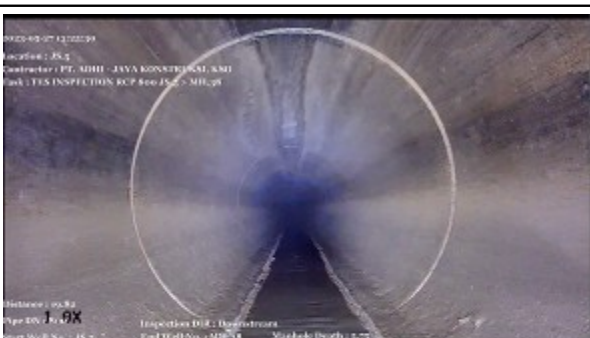
| Distance | Fault Observation | Time | Picture |
|---|---|---|---|
| 19.82 m | Remark: SAMBUNGAN KE 10 (OK) | 574 s | |

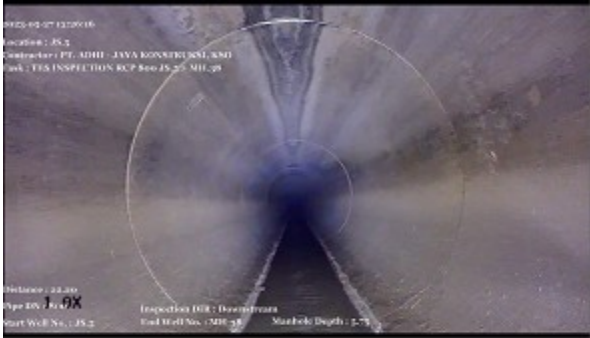
| Distance | Fault Observation | Time | Picture |
|---|---|---|---|
| 22.2 m | Remark: SAMBUNGAN KE 11 (OK) | 619 s | |

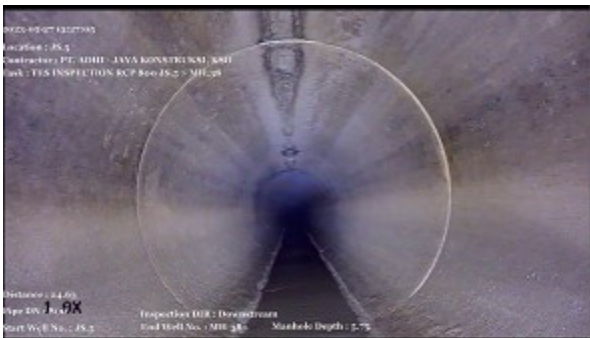
| Distance | Fault Observation | Time | Picture |
|---|---|---|---|
| 24.63 m | Remark: SAMBUNGAN KE 12 (OK) | 672 s | |

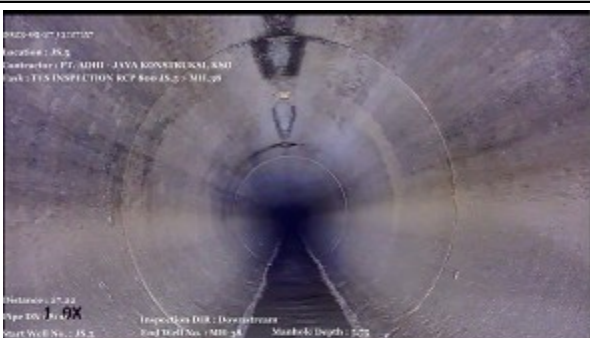
| Distance | Fault Observation | Time | Picture |
|---|---|---|---|
| 27.22 m | Remark: SAMBUNGAN KE 13 (OK) | 723 s | |

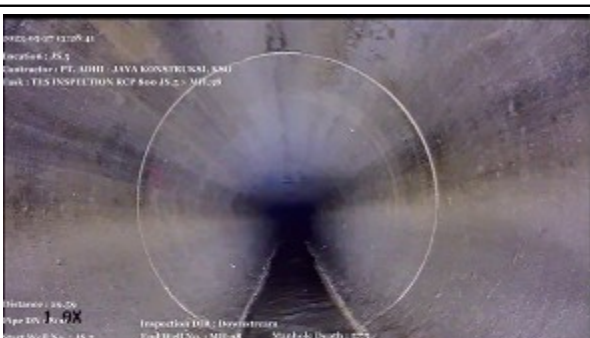
| Distance | Fault Observation | Time | Picture |
|---|---|---|---|
| 29.59 m | Remark: SAMBUNGAN KE 14 (OK) | 768 s | |

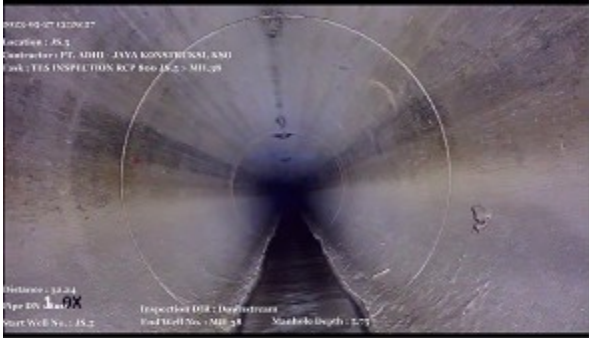
| Distance | Fault Observation | Time | Picture |
|---|---|---|---|
| 32.24 m | Remark: SAMBUNGAN KE 15 (OK) | 814 s | |

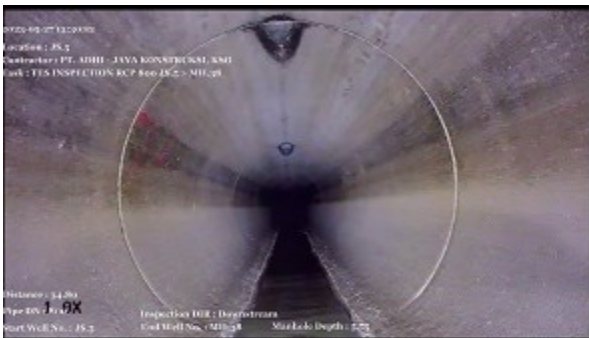
| Distance | Fault Observation | Time | Picture |
|---|---|---|---|
| 34.8 m | Remark: SAMBUNGAN KE 16 (OK) | 858 s | |

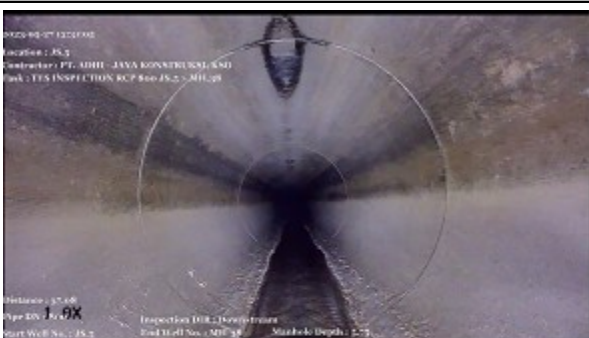
| Distance | Fault Observation | Time | Picture |
|---|---|---|---|
| 37.08 m | Remark: SAMBUNGAN KE 17 (OK) | 910 s | |

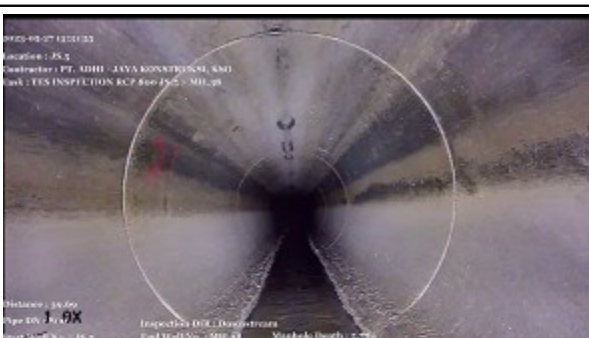
| Distance | Fault Observation | Time | Picture |
|---|---|---|---|
| 39.69 m | Remark: SAMBUNGAN KE 18 (OK) | 960 s | |

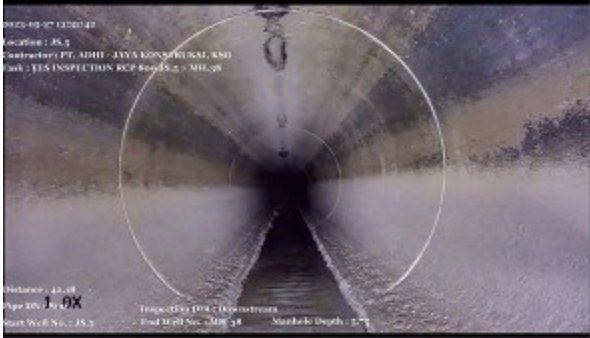
| Distance | Fault Observation | Time | Picture |
|---|---|---|---|
| 42.18 m | Remark: SAMBUNGAN KE 19 (OK) | 1008 s | |

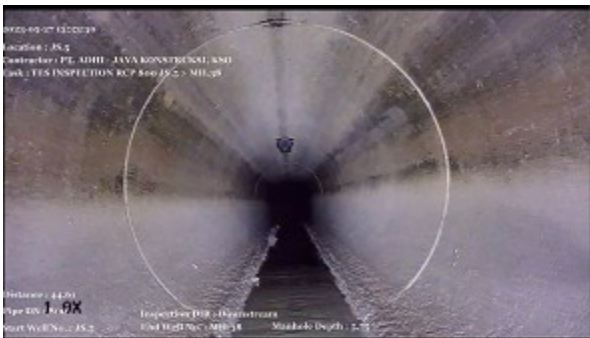
| Distance | Fault Observation | Time | Picture |
|---|---|---|---|
| 44.61 m | Remark: SAMBUNGAN KE 20 (OK) | 1057 s | |

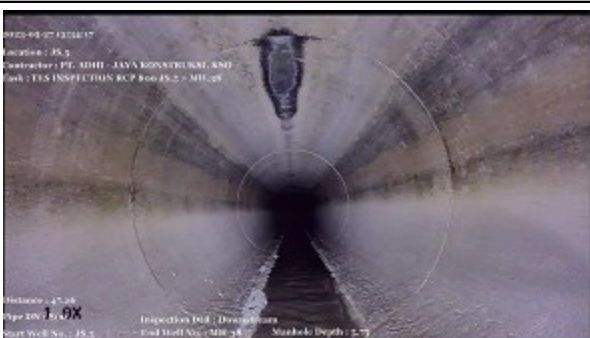
| Distance | Fault Observation | Time | Picture |
|---|---|---|---|
| 47.26 m | Remark: SAMBUNGAN KE 21 (OK) | 1104 s | |

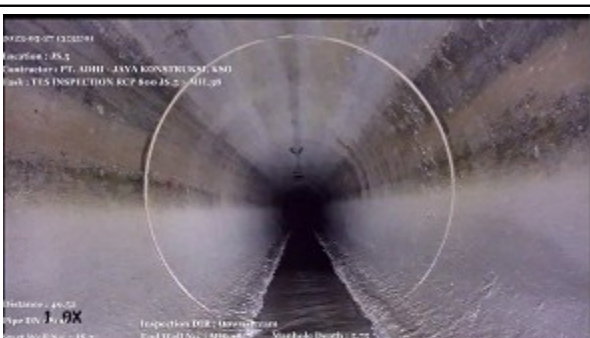
| Distance | Fault Observation | Time | Picture |
|---|---|---|---|
| 49.52 m | Remark: SAMBUNGAN KE 22 (OK) | 1146 s | |

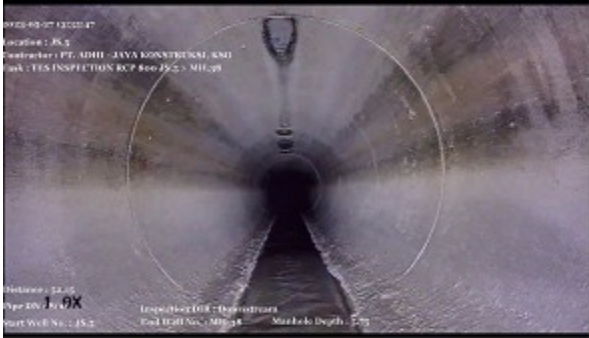
| Distance | Fault Observation | Time | Picture |
|---|---|---|---|
| 52.15 m | Remark: SAMBUNGAN KE 23 (OK) | 1194 s | |

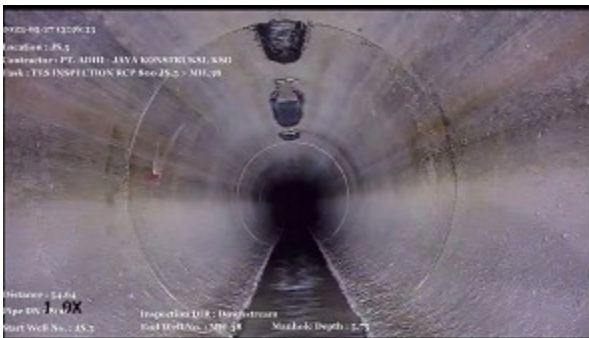
| Distance | Fault Observation | Time | Picture |
|---|---|---|---|
| 54.64 m | Remark: SAMBUNGAN KE 24 (OK) | 1239 s | |

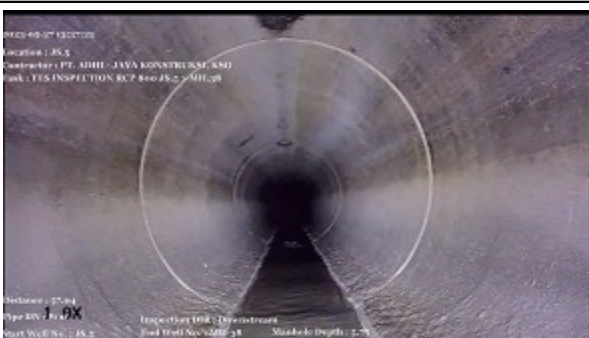
| Distance | Fault Observation | Time | Picture |
|---|---|---|---|
| 57.04 m | Remark: SAMBUNGAN KE 25 (OK) | 1285 s | |

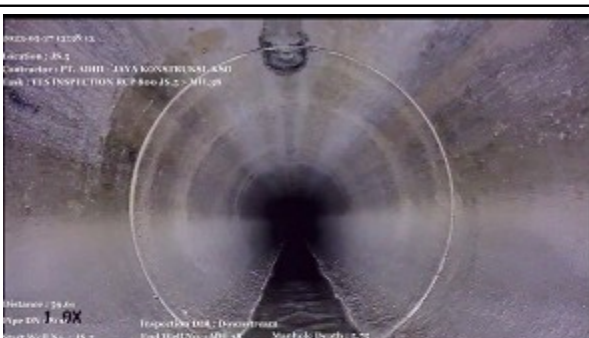
| Distance | Fault Observation | Time | Picture |
|---|---|---|---|
| 59.61 m | Remark: SAMBUNGAN KE 26 (OK) | 1341 s | |

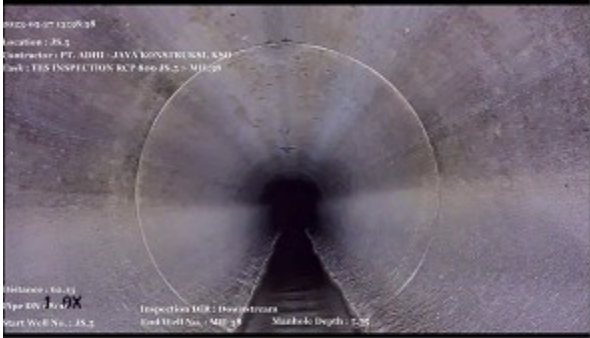
| Distance | Fault Observation | Time | Picture |
|---|---|---|---|
| 62.13 m | Remark: SAMBUNGAN KE 27 (OK) | 1385 s | |

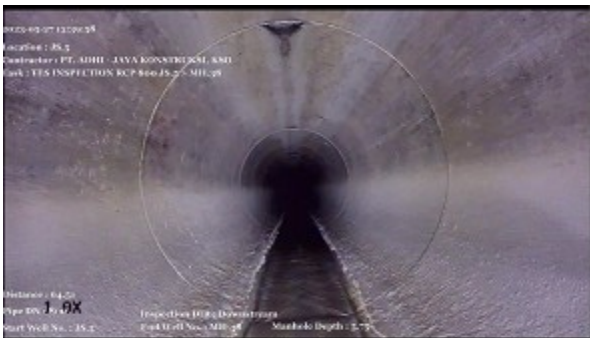
| Distance | Fault Observation | Time | Picture |
|---|---|---|---|
| 64.51 m | Remark: SAMBUNGAN KE 28 (OK) | 1445 s | |

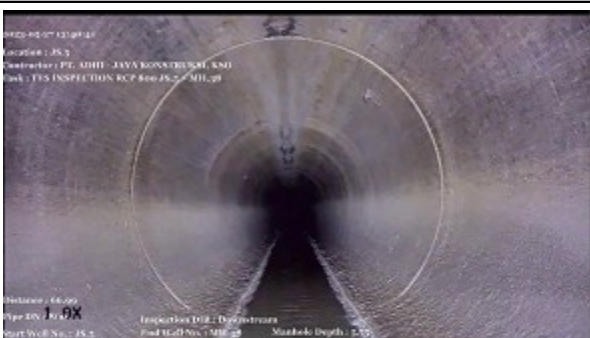
| Distance | Fault Observation | Time | Picture |
|---|---|---|---|
| 66.99 m | Remark: SAMBUNGAN KE 29 (OK) | 1488 s | |

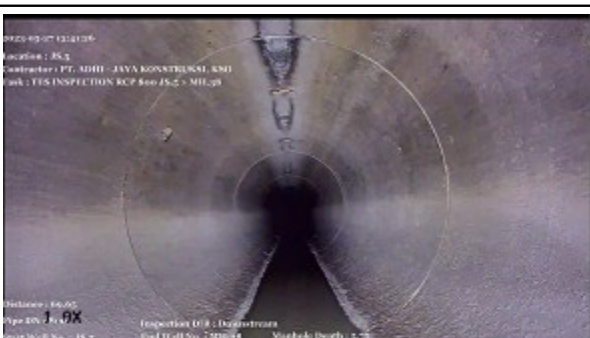
| Distance | Fault Observation | Time | Picture |
|---|---|---|---|
| 69.65 m | Remark: SAMBUNGAN KE 30 (OK) | 1533 s | |

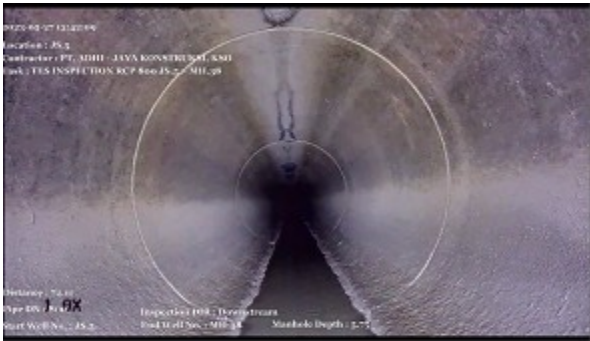
| Distance | Fault Observation | Time | Picture |
|---|---|---|---|
| 72.11 m | Remark: SAMBUNGAN KE 31 (OK) | 1576 s | |

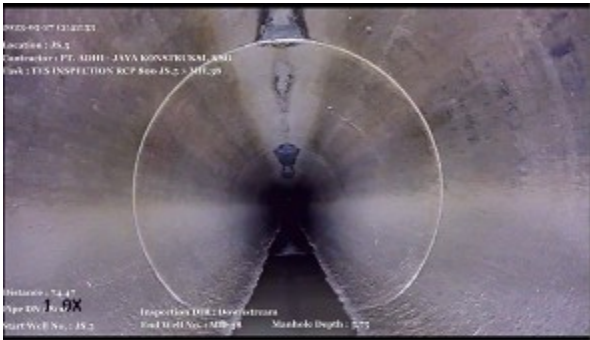
| Distance | Fault Observation | Time | Picture |
|---|---|---|---|
| 74.47 m | Remark: SAMBUNGAN KE 32 (OK) | 1621 s | |

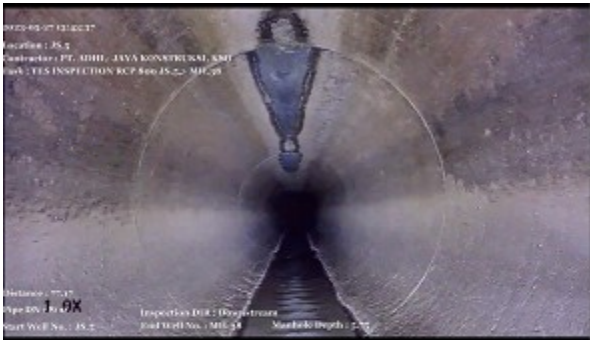
| Distance | Fault Observation | Time | Picture |
|---|---|---|---|
| 77.17 m | Remark: SAMBUNGAN KE 33 (OK) | 1664 s | |

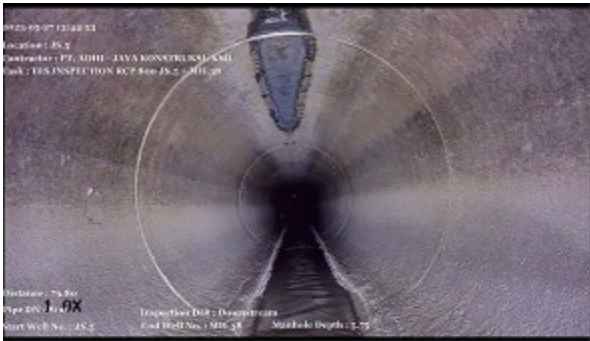
| Distance | Fault Observation | Time | Picture |
|---|---|---|---|
| 79.8 m | Remark: SAMBUNGAN KE 34 (OK) | 1710 s | |

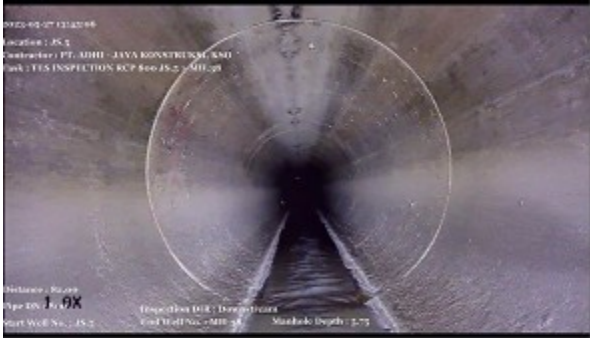
| Distance | Fault Observation | Time | Picture |
|---|---|---|---|
| 82 m | Remark: SAMBUNGAN KE 35 (OK) | 1753 s | |

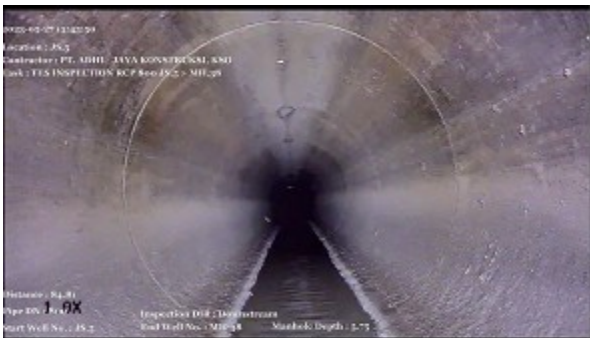
| Distance | Fault Observation | Time | Picture |
|---|---|---|---|
| 84.81 m | Remark: SAMBUNGAN KE 36 (OK) | 1797 s | |

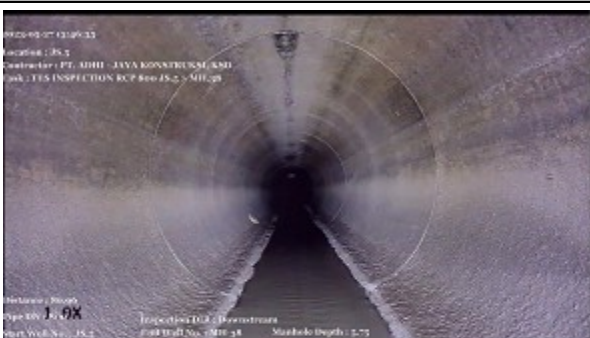
| Distance | Fault Observation | Time | Picture |
|---|---|---|---|
| 86.96 m | Remark: SAMBUNGAN KE 37 (OK) | 1840 s | |

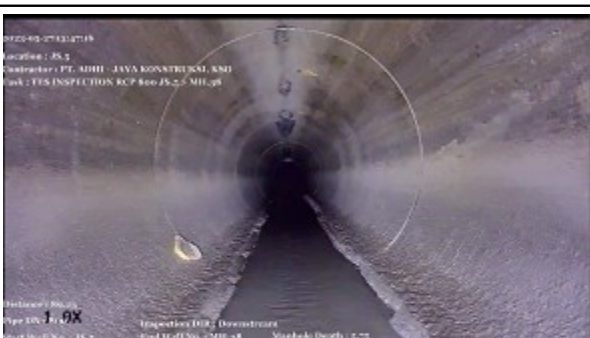
| Distance | Fault Observation | Time | Picture |
|---|---|---|---|
| 89.23 m | Remark: SAMBUNGAN KE 38 (OK) | 1884 s | |

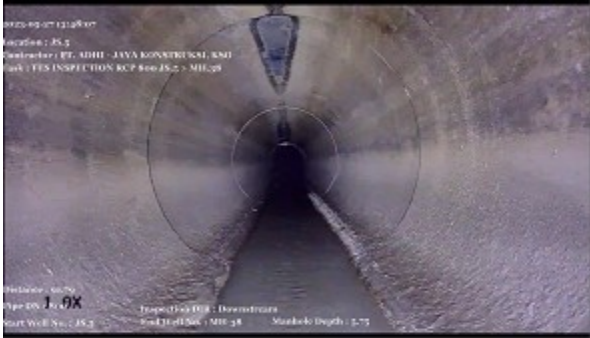
| Distance | Fault Observation | Time | Picture |
|---|---|---|---|
| 91.79 m | Remark: SAMBUNGAN KE 39 (OK) | 1935 s | |

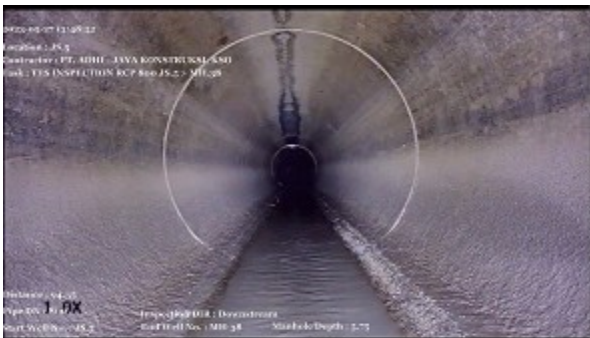
| Distance | Fault Observation | Time | Picture |
|---|---|---|---|
| 94.35 m | Remark: SAMBUNGAN KE 40 (OK) | 1980 s | |

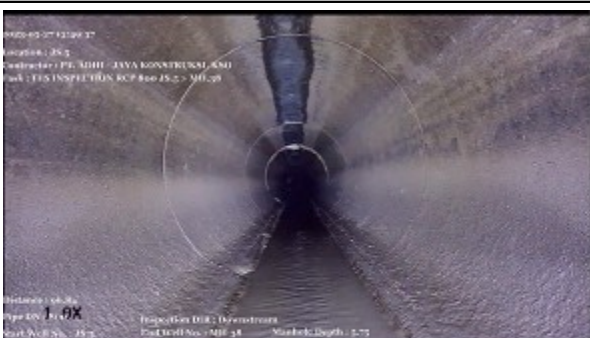
| Distance | Fault Observation | Time | Picture |
|---|---|---|---|
| 96.84 m | Remark: SAMBUNGAN KE 41 (OK) | 2022 s | |

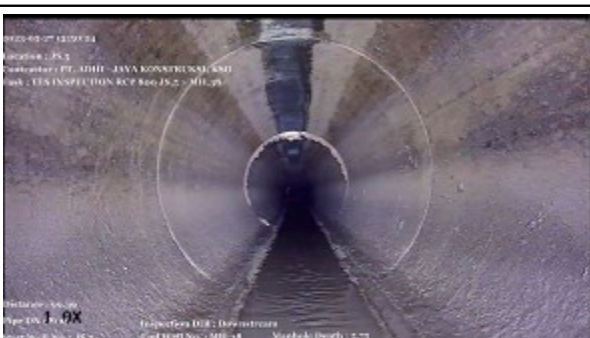
| Distance | Fault Observation | Time | Picture |
|---|---|---|---|
| 99.39 m | Remark: SAMBUNGAN KE 42 (OK) | 2070 s | |

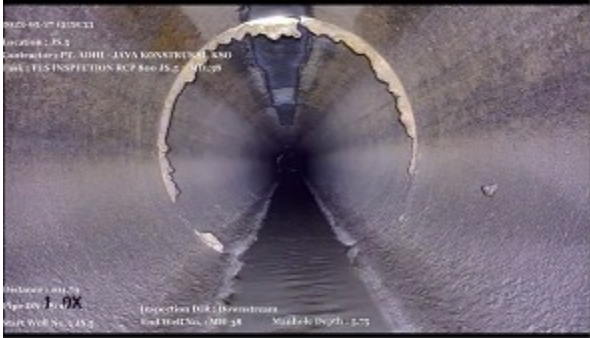
| Distance | Fault Observation | Time | Picture |
|---|---|---|---|
| 101.79 m | Remark: SAMBUNGAN KE 43 (OK) | 2140 s | |

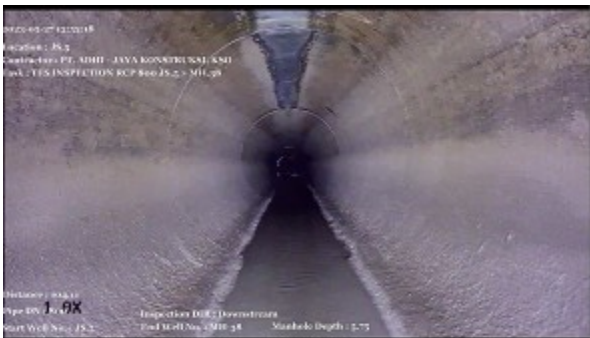
| Distance | Fault Observation | Time | Picture |
|---|---|---|---|
| 104.11 m | Remark: SAMBUNGAN KE 44 (OK) | 2185 s | |

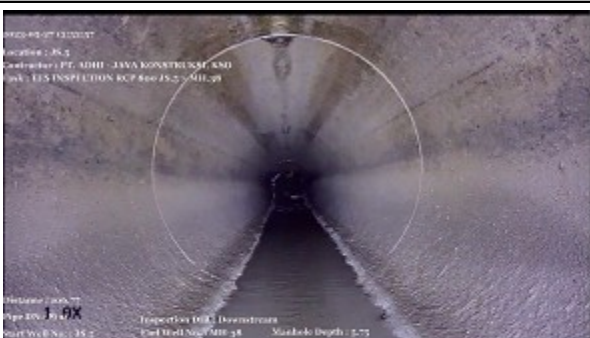
| Distance | Fault Observation | Time | Picture |
|---|---|---|---|
| 106.77 m | Remark: SAMBUNGAN KE 45 (OK) | 2221 s | |

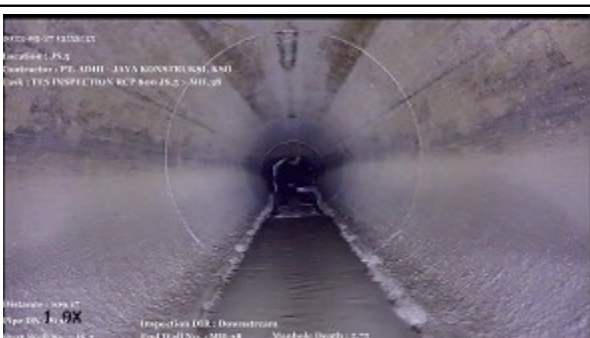
| Distance | Fault Observation | Time | Picture |
|---|---|---|---|
| 109.17 m | Remark: SAMBUNGAN KE 46 (OK) | 2261 s | |

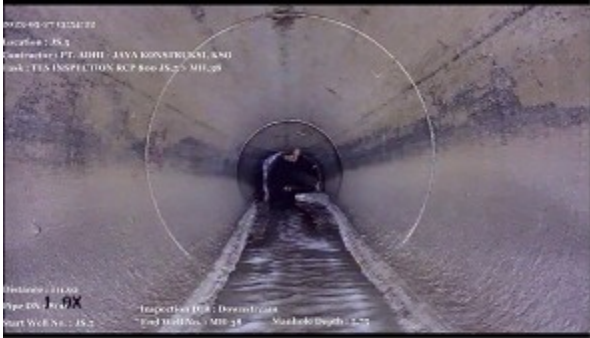
| Distance | Fault Observation | Time | Picture |
|---|---|---|---|
| 111.92 m | Remark: SAMBUNGAN KE 47 (OK) | 2306 s | <p> <small> 0020-09-07 13:54:07<br/> Location : JS.5<br/> Contractor : PT. ADHI - JAYA KONSTRUKSI, KSO<br/> Work : TUN TUNNELING RCP 800 JS.5 - MH.25<br/> Distance : 111.92<br/> Pipe ID : 1.0X<br/> Inspection ID : D000000000<br/> Start Work No. : JS.2<br/> End Work No. : MH.25<br/> Max Depth : 1.75 </small> </p> |

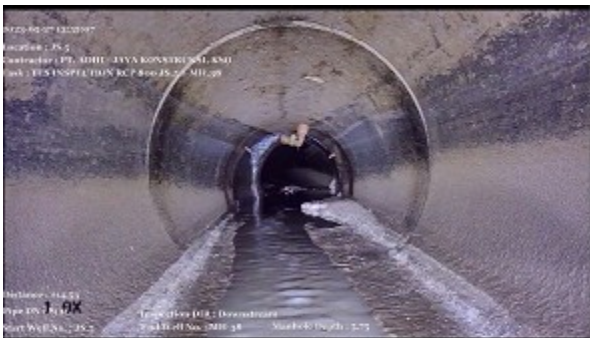
| Distance | Fault Observation | Time | Picture |
|---|---|---|---|
| 114.53 m | Remark: SAMBUNGAN KE 48 (OK) | 2352 s | <p> <small> 0020-09-07 13:59:07<br/> Location : JS.5<br/> Contractor : PT. ADHI - JAYA KONSTRUKSI, KSO<br/> Work : TUN TUNNELING RCP 800 JS.5 - MH.25<br/> Distance : 114.53<br/> Pipe ID : 1.0X<br/> Inspection ID : D000000000<br/> Start Work No. : JS.2<br/> End Work No. : MH.25<br/> Max Depth : 1.75 </small> </p> |

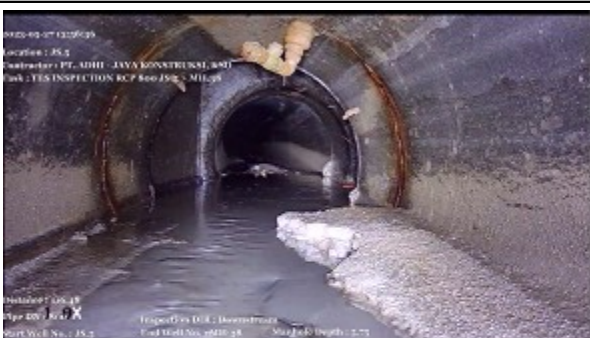
| Distance | Fault Observation | Time | Picture |
|---|---|---|---|
| 116.48 m | Remark: SAMBUNGAN KE 49 ( ..... ) | 2443 s | <p> <small> 0020-09-07 14:06:05<br/> Location : JS.5<br/> Contractor : PT. ADHI - JAYA KONSTRUKSI, KSO<br/> Work : TUN TUNNELING RCP 800 JS.5 - MH.25<br/> Distance : 116.48<br/> Pipe ID : 1.0X<br/> Inspection ID : D000000000<br/> Start Work No. : JS.2<br/> End Work No. : MH.25<br/> Max Depth : 1.75 </small> </p> |
